**QUINQUENNIAL CONDITION REPORT**

**CHURCH OF SCOTLAND  
CARE OF ECCLESIASTICAL PROPERTIES**

**ABBOTSHALL CHURCH HALL  
23 CLOANDEN PLACE  
KIRKCALDY**

**MAY 2015**

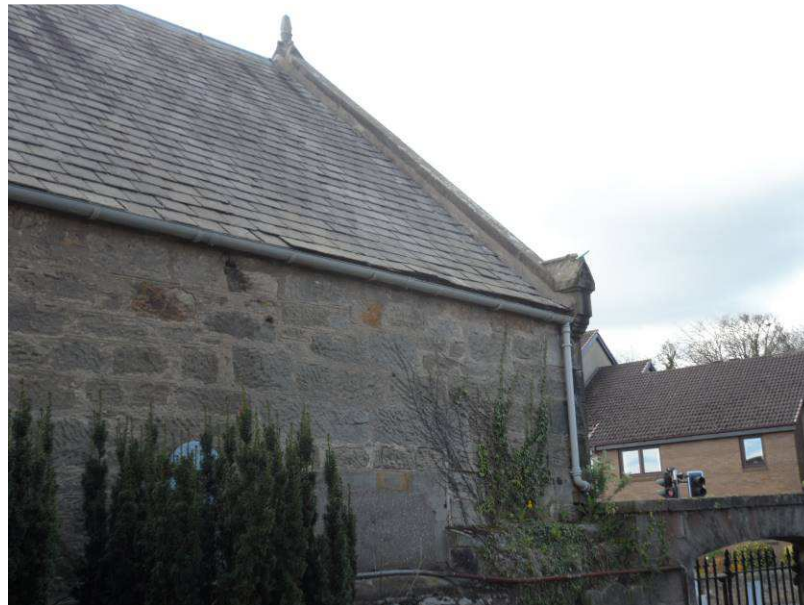
View of uplift to slates

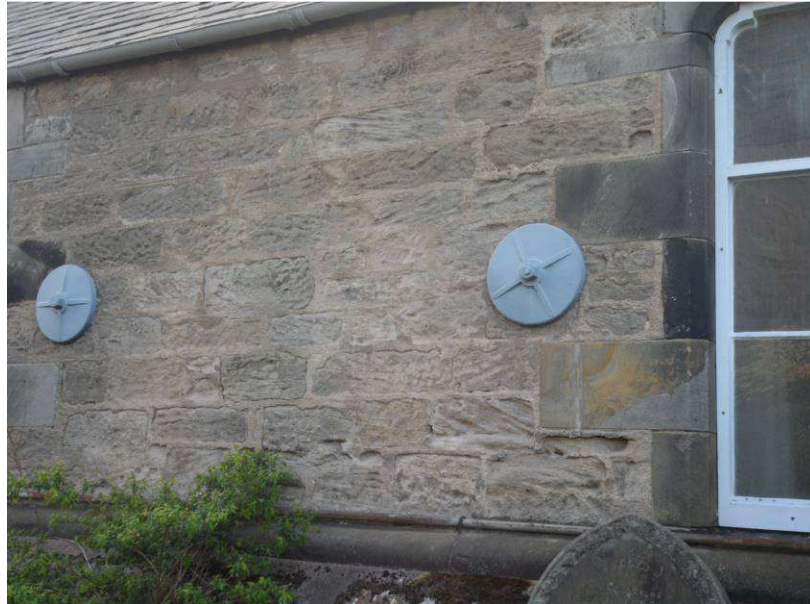
View of typical stone erosion

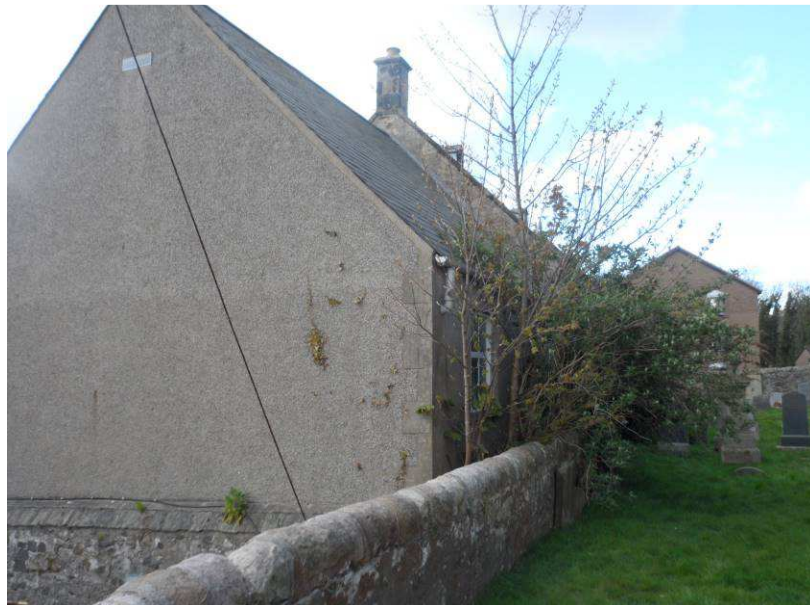
View of vegetation growth between building and boundary

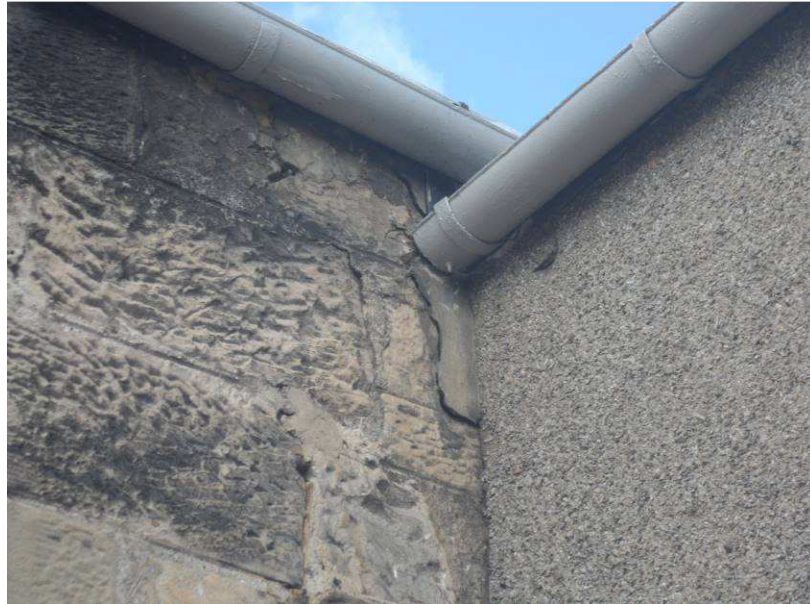
View of cracking to front elevation

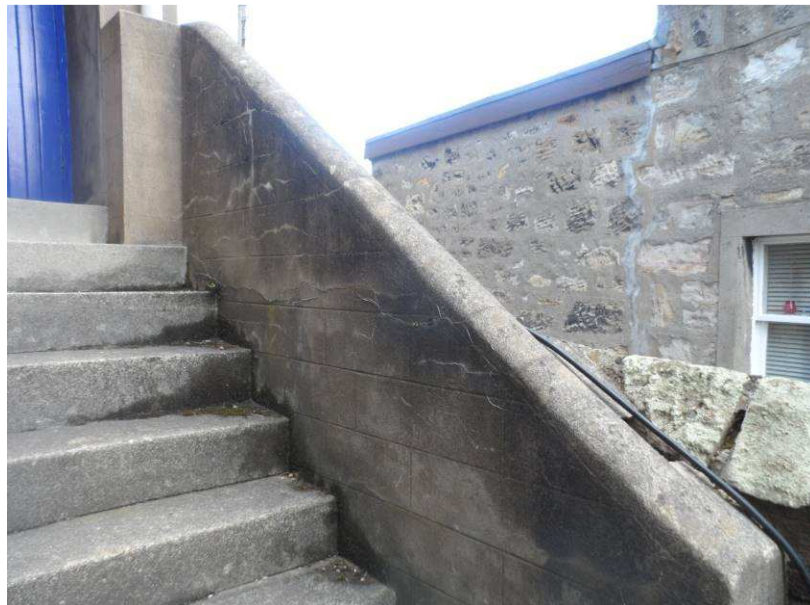
Steps leading to entrance, facing brick finished with smooth cement render.	Reasonable. Render spalling.	Clean off loose render and prove key for new render.	D			65
G.2	<b>Boundaries</b>	Rubble stone boundary walls and copes	Poor. Mortar beds spalling in places and major delamination of sandstone in places.	Re-point wall where required and replace stone.	E		450

View of cracking to smooth render at steps to front elevation

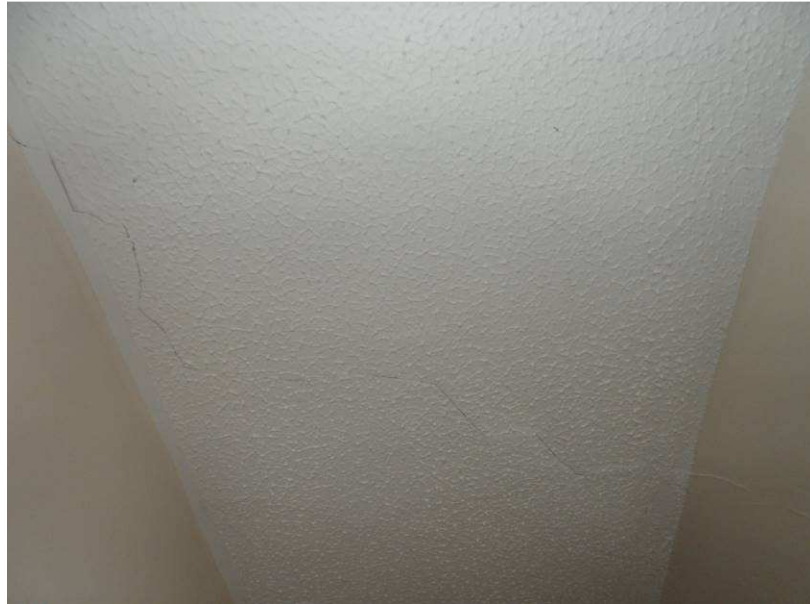
View of cracking to ceiling within entrance hall

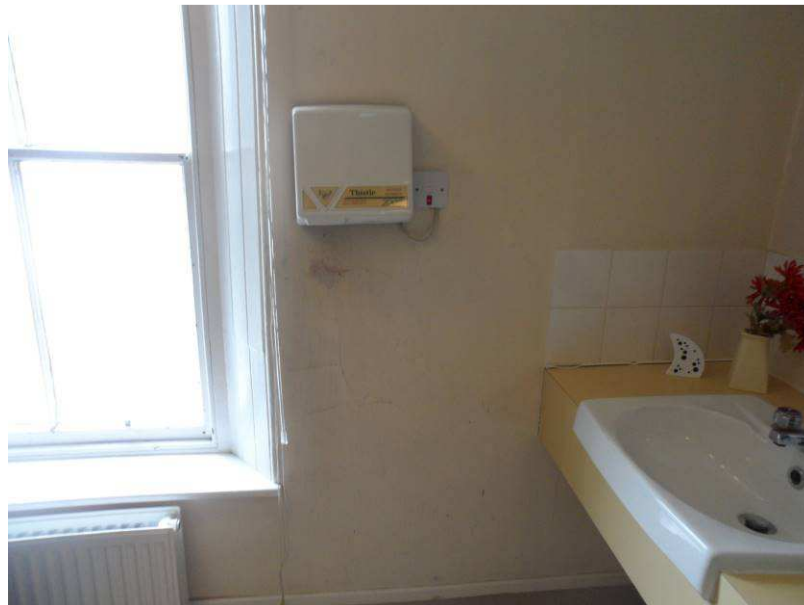
View of deterioration to wall decoration from hand drier used in Ladies WC

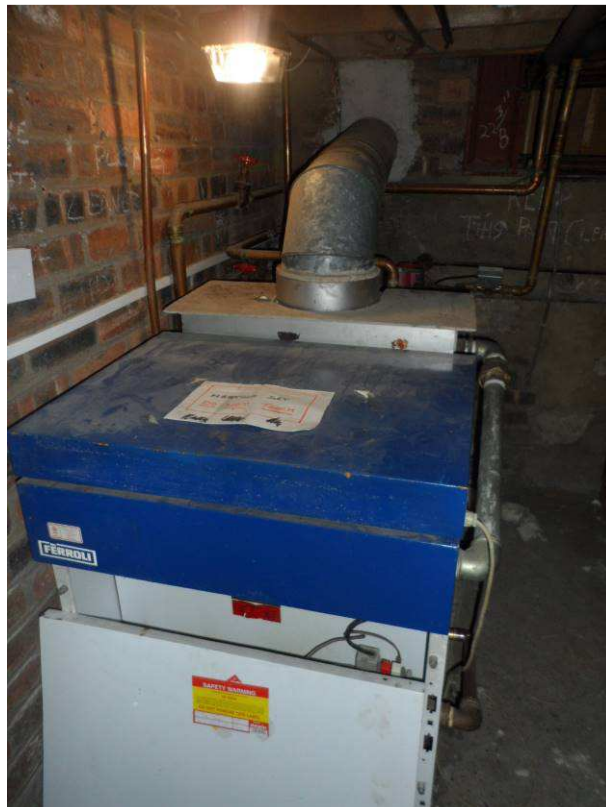
View of current boiler system

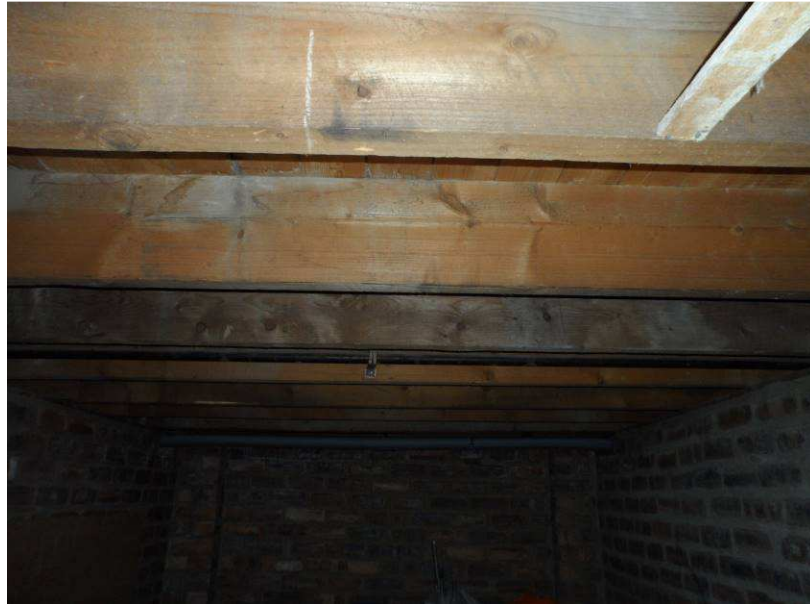
View of timbers within basement

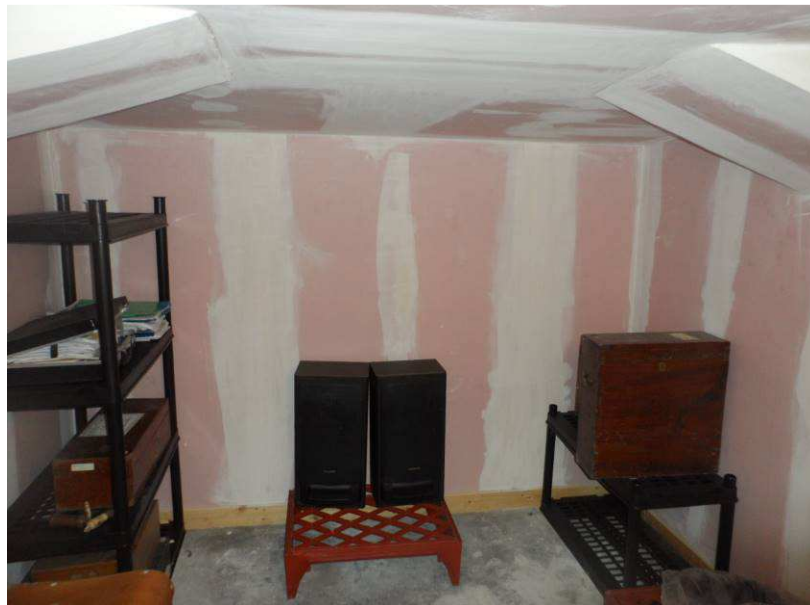
View of new safe within basement
