**QUINQUENNIAL CONDITION REPORT**

**CHURCH OF SCOTLAND  
CARE OF ECCLESIASTICAL PROPERTIES**

**ABBOTSHALL MANSE  
83 MILTON ROAD  
KIRKCALDY**

**APRIL 2015**

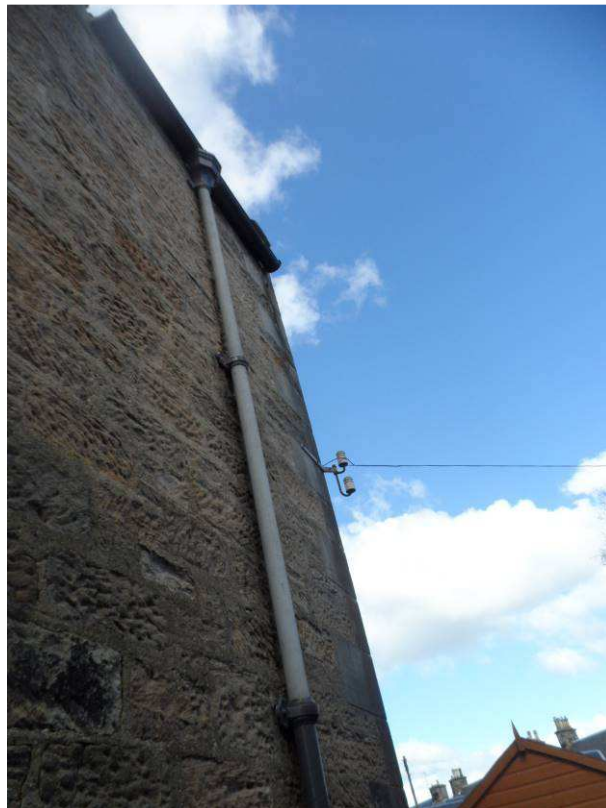
View of unpainted downpipes

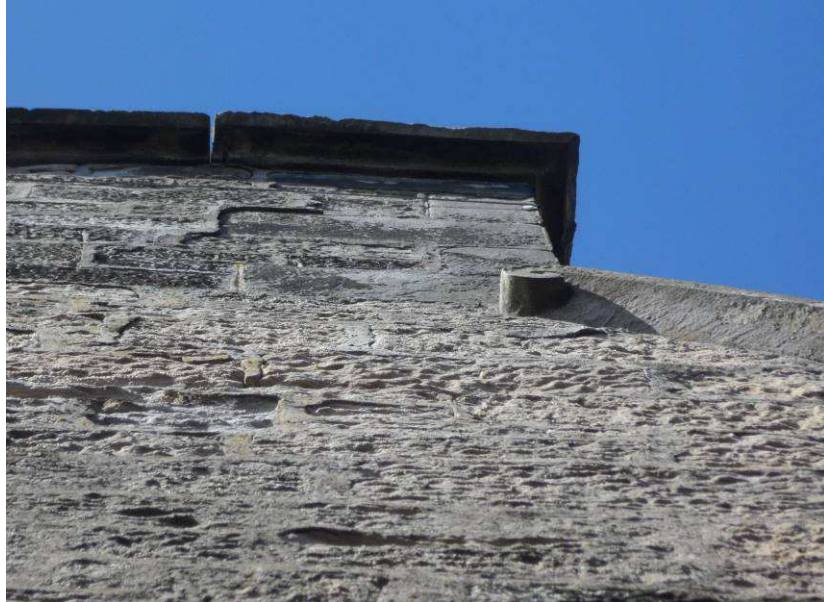
There is some movement noted to the east chimney stack and this should be further inspected to ascertain its integrity.

View of movement to east chimney stack

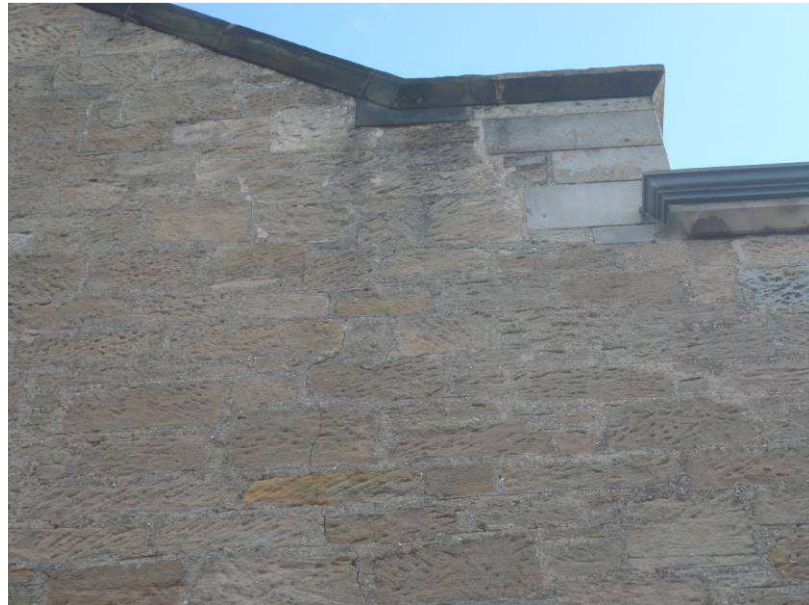
View of minor cracking to west elevation

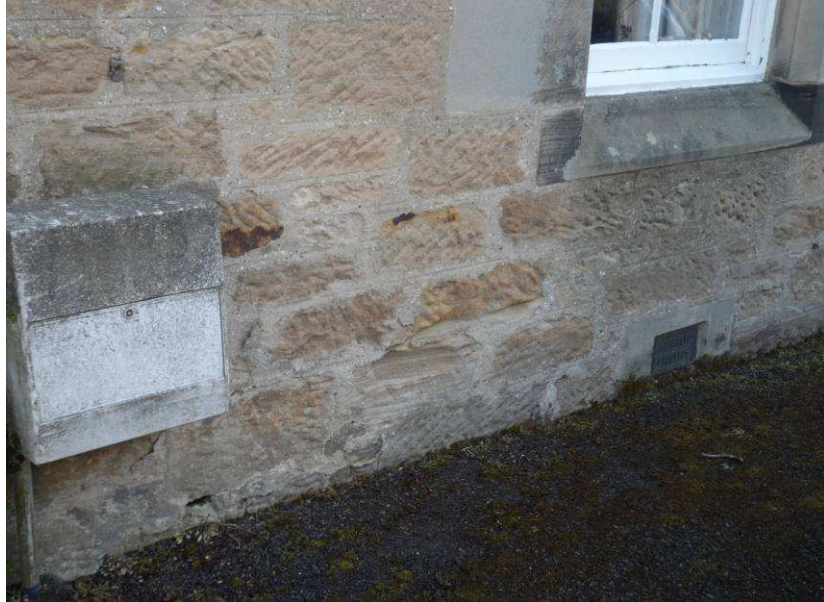
Overall the property is in a reasonable condition for a building of this age, albeit externally the stonework is showing isolated signs of erosion and weathering, and some missing pointing.

View of typical erosion to stonework

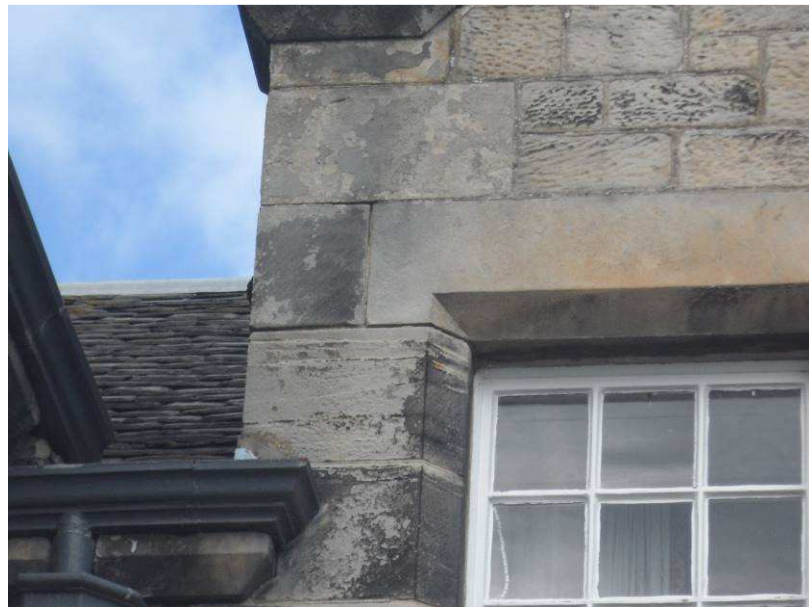
View of missing pointing to front elevation

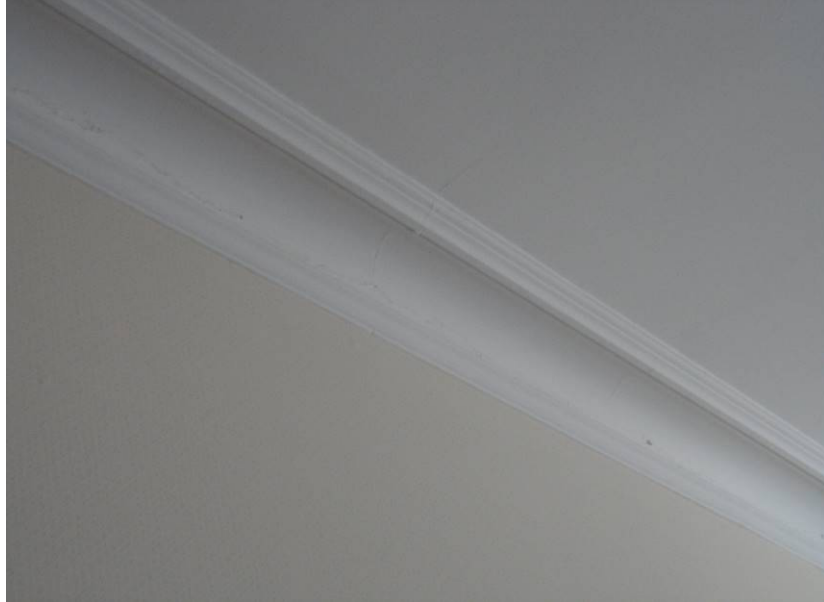
View of cracking to cornice in the lounge

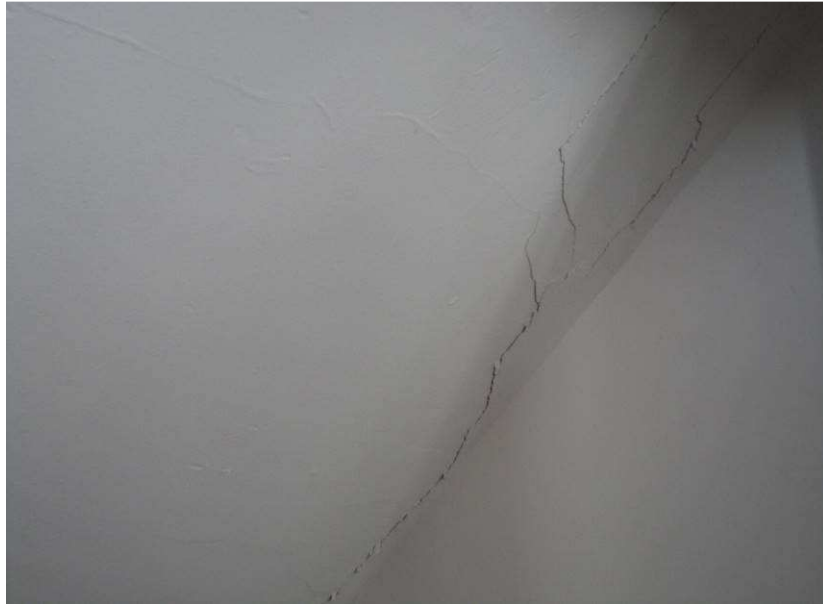
View of cracking under stairs in entrance cupboard

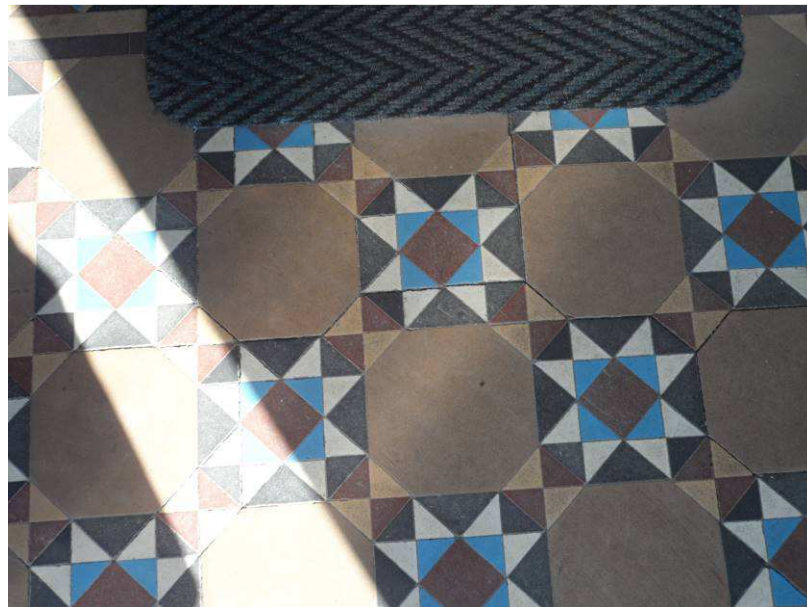
Floors	Concrete floor with patterned finish, tiled.	Good/Reasonable, grout missing.	Re-grout.	E		50	
	Lighting and Power	1No light fitting.	Appears in working order.	None.

View of missing grout to tiles at entrance door
